# Drone Inspection Report

| CLIENT | North Ridge Energy |
| SITE | Ridgeway Solar & Substation |
| REPORT ID | FS-DR-20260708-017 |

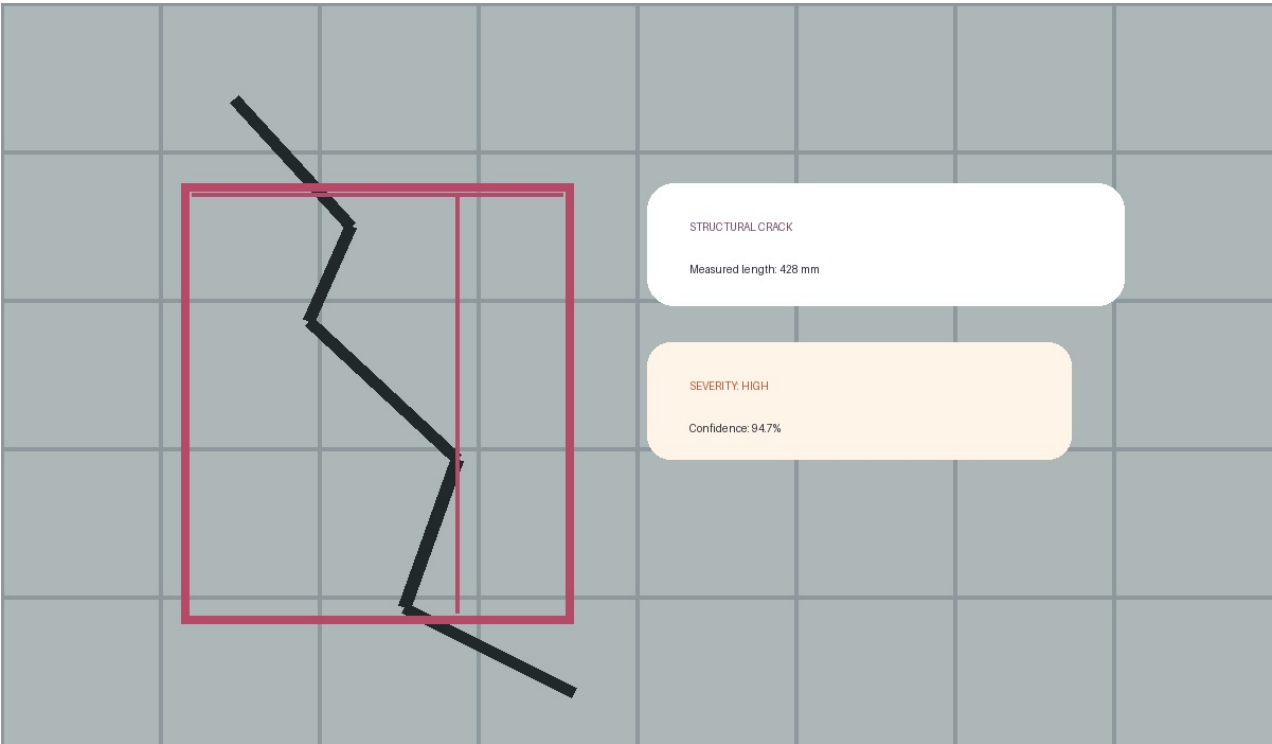
FINDING F-002

## Longitudinal concrete crack

| Asset | Substation wall E-14 |
| Defect type | Structural crack |
| Measured length | 428 mm |
| Estimated width | 2.8 mm |
| Severity | High |

Crack length increased 37.2% over 81 days. Severity changed from Medium to High.

| ENGINEERING REVIEW | F-002 | Confirm crack cause, moisture pathway, and repair specification. | Civil engineer<br>Owner | 10 Jul 2026<br>Due |

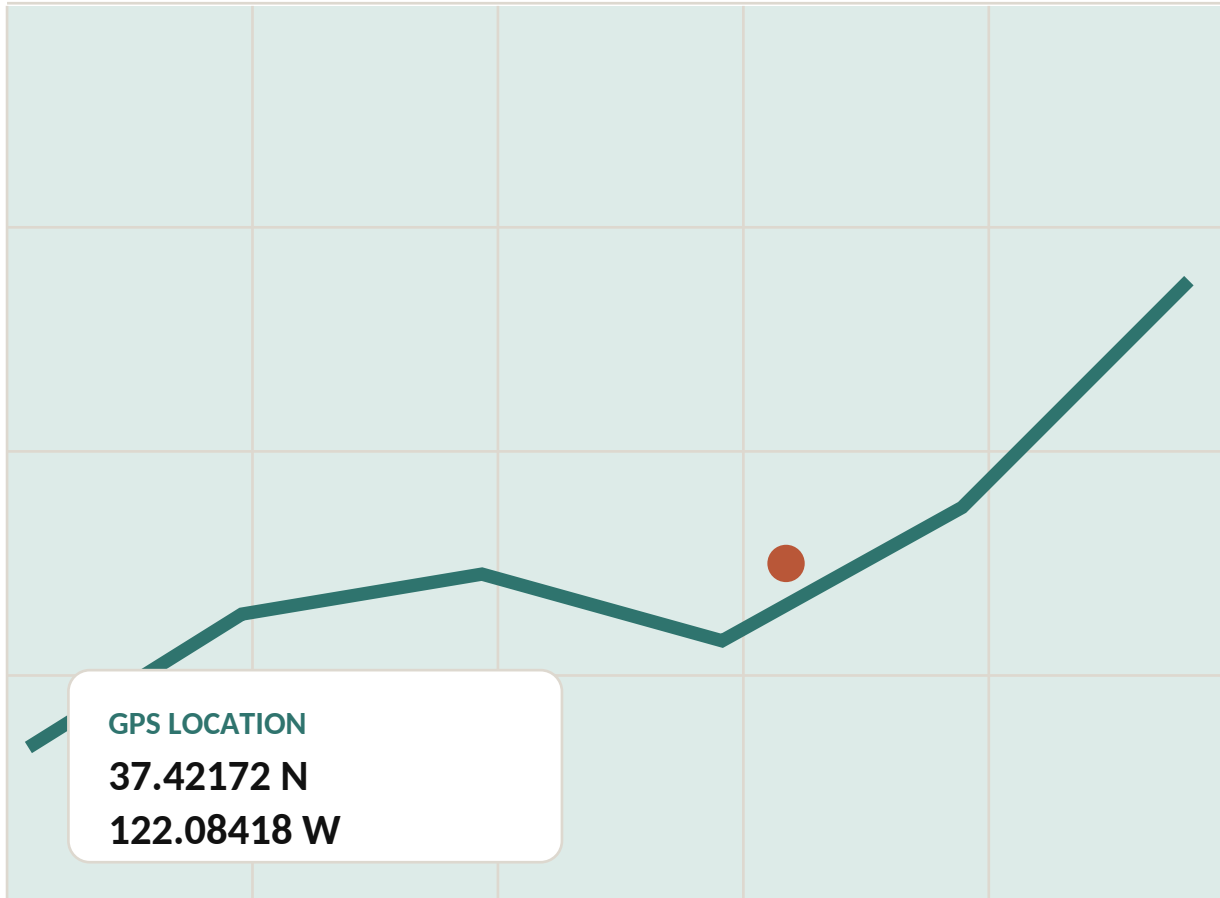
### Substation wall / E-14

East elevation • Segment 05

2.4 m above finished grade

Altitude: 31.8 m AMSL

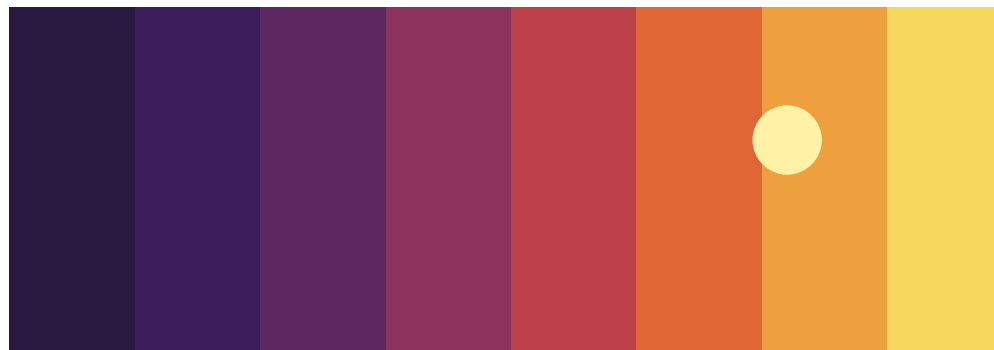
## THERMAL MAP / RADIOMETRIC

54.7 C

31.6 C

37.8 C

33.1 C

Thermal delta: +16.9 C above surrounding panel string

| CONTINUED MONITORING | F-005 | Repeat thermal scan after load normalization and compare delta T. | Asset analyst<br>Owner | 08 Aug 2026<br>Due |
